FLOOD PLAIN INFORMATION

LITTLE BUSHKILL CREEK AND SHOENECK CREEK
NORTHAMPTON COUNTY, PENNSYLVANIA

PREPARED FOR THE LEHIGH-NORTHAMPTON COUNTY JOINT PLANNING COMMISSION BY THE
DEPT. OF THE ARMY, PHILADELPHIA DISTRICT, CORPS OF ENGINEERS, PHILADELPHIA, PA.

APRIL 1973

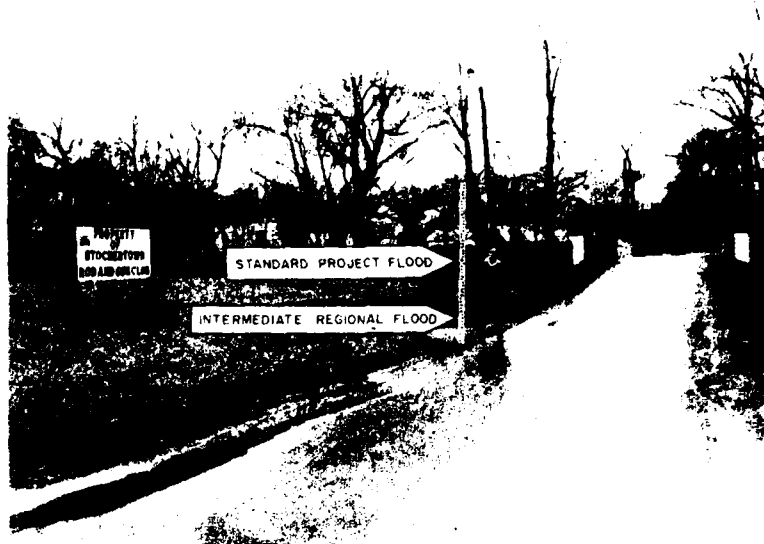
FUTURE 3 - Future flood heights of Little Bushkill Creek at Lefevre Street, Stockertown, Pa.

Photographs, future flood heights - The levels that the Intermediate Regional and Standard Project Floods are expected to reach at various locations along Little Bushkill and Shoeneck Creeks are indicated on the following photographs.

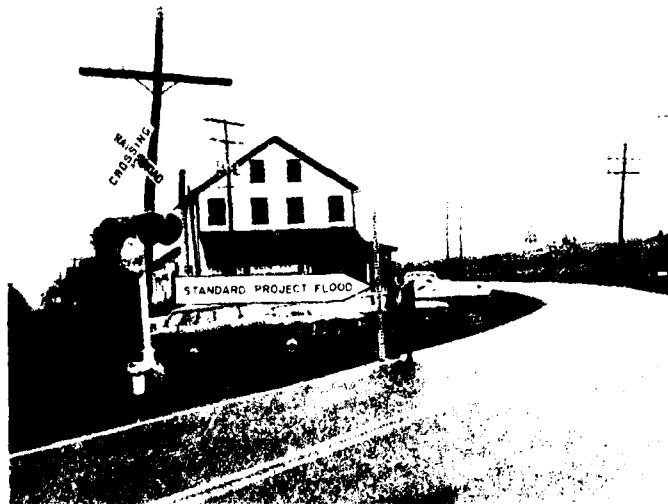
FIGURE 4 - Future flood height of Little Bushkill Creek on Pa. Rt. 191, Edleman, Pa.

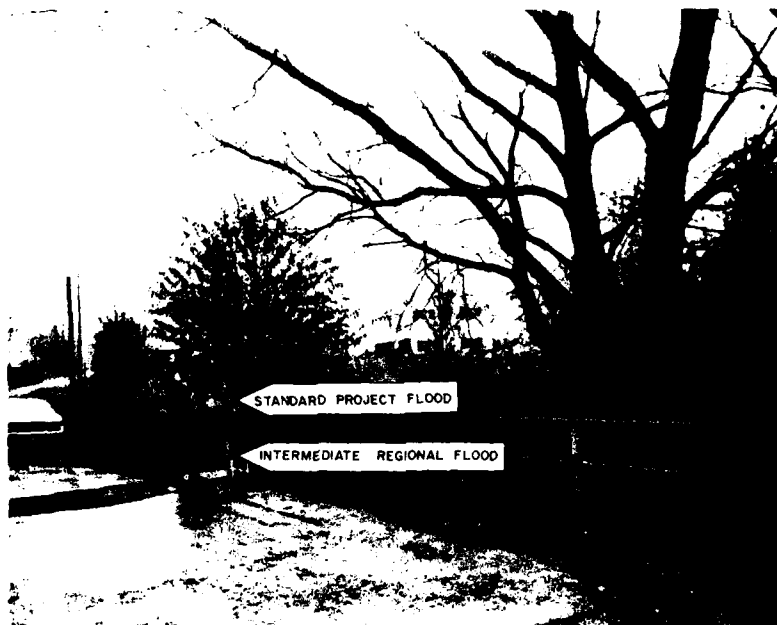
FIGURE 5 - Future flood heights of Little Bushkill Creek at the Plainfield Township Road 629 bridge.

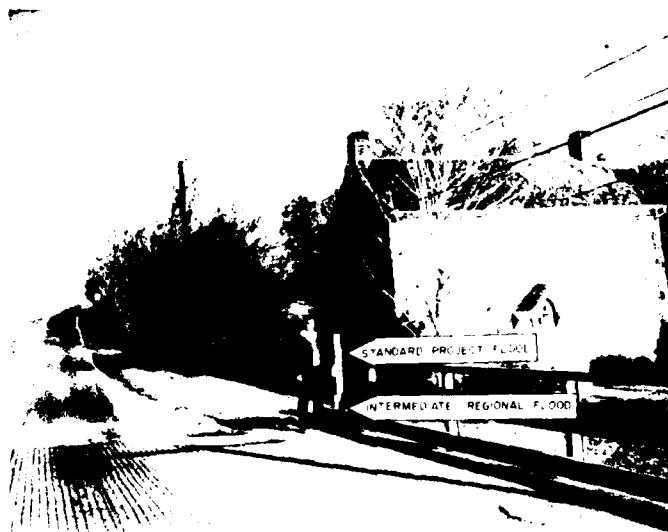
FIGURE 6 - Future flood heights at the Tatamy Road bridge on Shoeneck Creek.

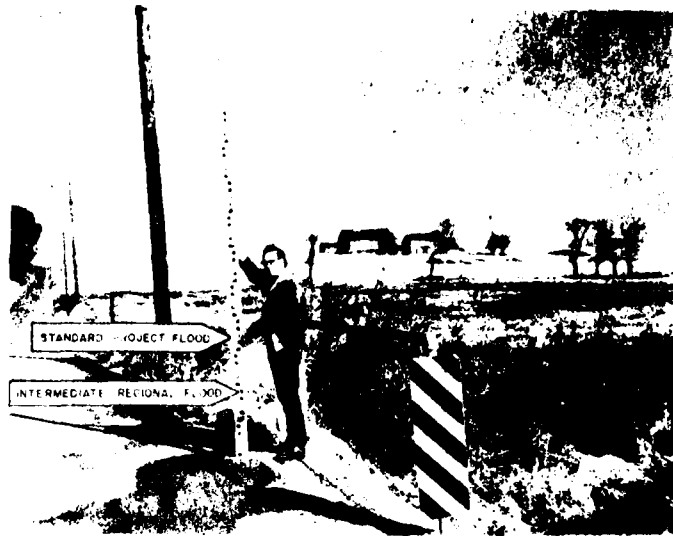
FIGURE 7 - Future flood heights at the Van Buren Road bridge on Shoeneck Creek.

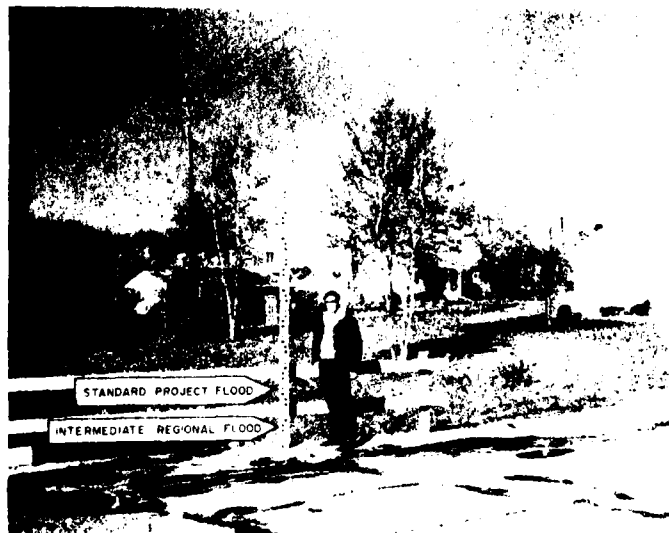
FIGURE 8 - Future flood heights at the North Liberty Street bridge on Shoeneck Creek.
